Eurasian water-milfoil (*Myriophyllum spicatum*) Late Summer Bed Mapping Survey Sand Bar Lake - WBIC: 24924900 Bayfield County, Wisconsin

Endangered Resource Services, LLC Matthew S. Berg, Research Biologist St. Croix Falls, Wisconsin August 24, 2025

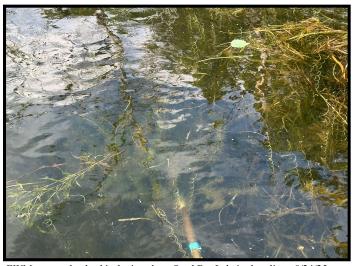
EWM among the dead jack pine along Sand Bar Lake's shoreline - 8/24/25

Bed 1A – EWM in this area was almost exclusively found growing among the flooded dead Jack pines along the shoreline. Although currently unlikely to be an impairment to navigation, it is also likely a difficult area for manual removal.

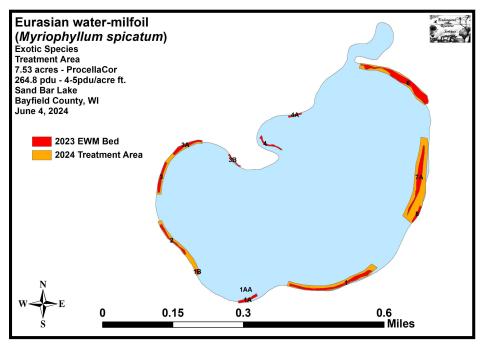
Figure 3: Eurasian Water-milfoil Treatment Areas - June 4, 2024

In the spring of 2024, the TOB treated five areas around the lake totaling 7.53 acres (5.93% of the lake's total surface area) (Table 1). Treatment occurred on June 4th with Northern Aquatic Services (Dale Dressel - Dresser, WI) applying ProcellaCor at a target rate of 4-5pdu/acre-ft (264.8 total pdu) (Figure 3) (Appendix I). The reported water temperature at the time of treatment was 67°F, the ambient air temperature was 66°F, and winds were out of the south at 2-4mph.

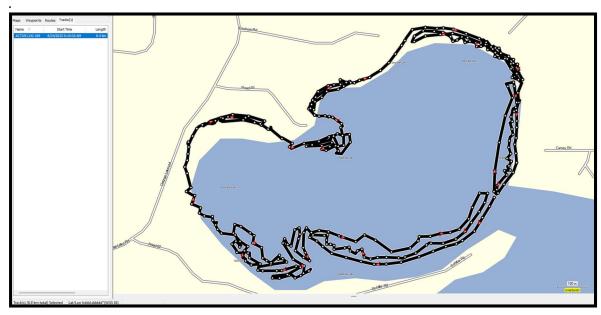
Figure 4: August 24, 2025 EWM Littoral Zone Survey – GPS Tracks

On August 24, 2025, we searched 8.9km (5.5 miles) of transects throughout the lake's visible littoral zone (Figure 4). We had partly sunny skies and relatively calm winds that allowed us to see down in the water approximately 8-10ft. We found the 2024 treatment areas continued to be nearly free of EWM, while areas not treated had small beds. In total, we mapped six microbeds covering 0.14 acre (0.11% of the lake's surface area) and rake removed six isolated plants (Figure 5). This represented a 3.33-acre (-95.97%) decline compared to the 2023 survey when we found 13 beds on 3.47 acres (2.73% surface area). The 2025 total was also a 1.07-acre (-88.43%) decline compared to 2022 when we found eight beds covering 1.21 acres (0.95% surface area) (Table 2).

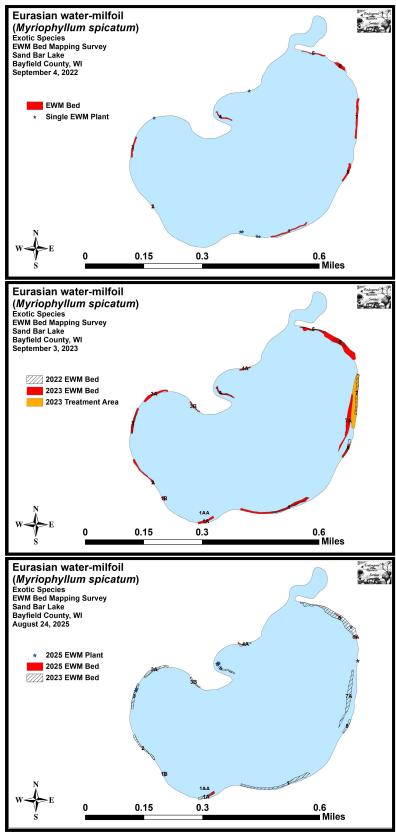
Figure 5: 2022, 2023, and 2025 Late Summer EWM Bed Maps

Beds 1, 1AA, 1B, and 2 – We saw no evidence of Eurasian water-milfoil in these former beds.

Bed 3 – We found, and rake removed two plants along the western shoreline.

Bed 3A – This microbed in the northwest bay was little more than a narrow continuous strip of plants. Although not likely to cause impairment, its proximity to a dock make it likely to be prop-clipped in the future. Because of this, it is probably a priority for manual removal in 2026.

Bed 3B – We saw no evidence of EWM in this former bed.

Beds 4 and 4A - Similar to Bed 1A, most EWM in these areas was found growing among or just out from the ring of dead trees on the lake's margin.

Beds 5 and 6 – On the north and northeast shorelines, we saw no evidence of EWM in Bed 5 and only scattered plants in the nearshore areas of Bed 6.

Bed 6A - Just southeast of Bed 6, we delineated a small but moderately dense deepwater bed that represented the worst EWM area on the lake.

Bed 7 - A single plant was found and raked out of the area formerly covered by Bed 7.

Beds 7A and 8 – We saw no EWM on the eastern shoreline near Tomahawk Lake.
