**Curly-leaf pondweed (*Potamogeton crispus*)
Bed Mapping Survey
Upper Eau Claire Lake – WBIC: 2742700
Bayfield County, Wisconsin**

Survey Conducted by and Report Prepared by:

Endangered Resource Services, LLC
Matthew S. Berg, Research Biologist
St. Croix Falls, Wisconsin
June 14, 2024

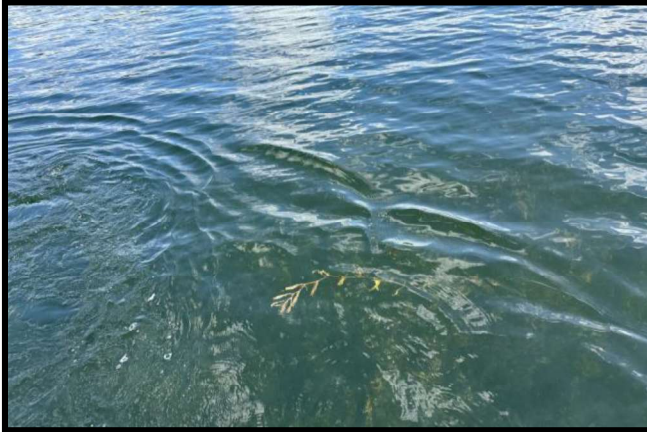
Curly-leaf pondweed bed in Upper Eau Claire Lake's southwest bay - 6/14/24

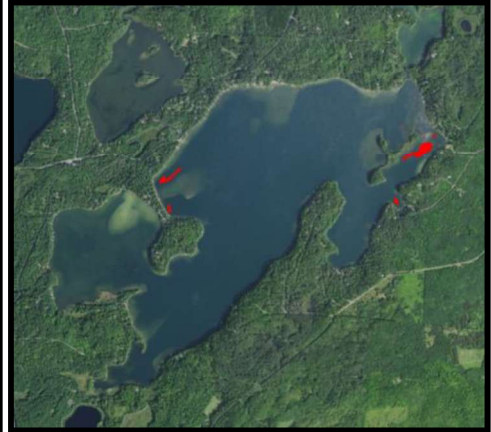
Upper Eau Claire Lake aerial photo with 2024 CLP beds.

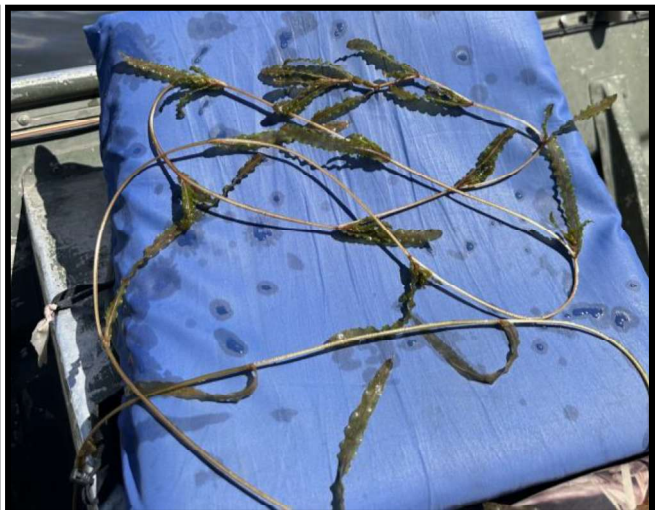
Curly-leaf pondweed in the outlet bay narrows in Upper Eau Claire Lake's – 6 14 24

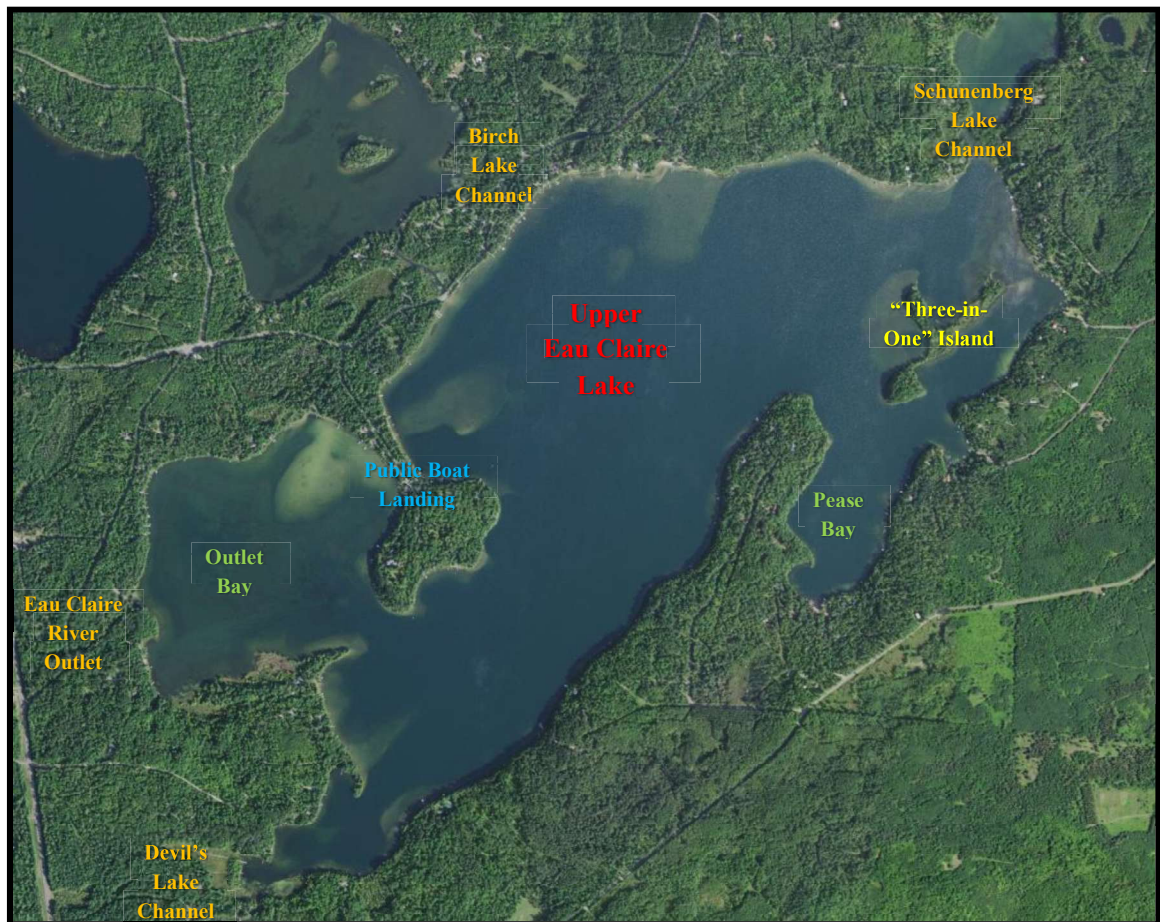
Figure 1: Upper Eau Claire Lake Aerial Photo

Upper Eau Claire Lake (WBIC 2742700) is a 1,024-acre stratified drainage lake located in southwestern Bayfield County, Wisconsin in the Town of Barnes (T44N R9W S2-3, 9-11, and 15-16). It reaches a maximum depth of 92ft in the hole due west of Three-in-One Island and has an average depth of approximately 29ft (Figure 1). The lake is oligotrophic in nature with summer Secchi readings over the last ten years averaging 18.4ft (WDNR 2024). This very good clarity produced a littoral zone that reached over 20ft in 2024. The bottom substrate is predominately sand and sandy muck, although areas of gravel are located throughout the lake – especially around exposed points and on shallow flats and sunken islands (Eaton et al 1974).
