**Curly-leaf pondweed (*Potamogeton crispus*)  
Bed Mapping Survey  
Lower Eau Claire Lake – WBIC: 2741600  
Douglas and Bayfield Counties, Wisconsin**

Endangered Resource Services, LLC  
Matthew S. Berg, Research Biologist  
St. Croix Falls, Wisconsin  
June 15, 2024

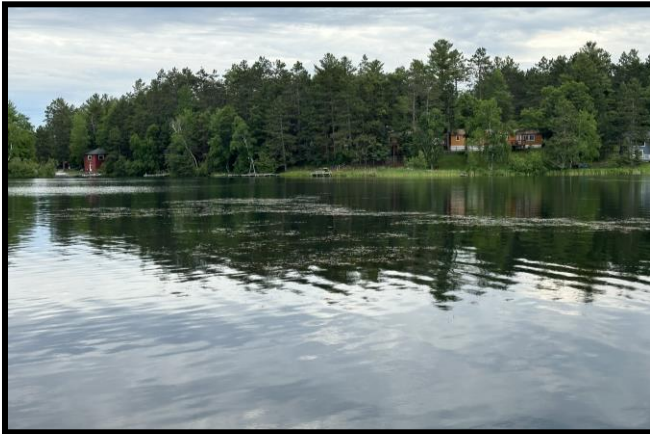
Canopied Curly-leaf pondweed – Lower Eau Claire Lake Outlet Bay – 6/15/24

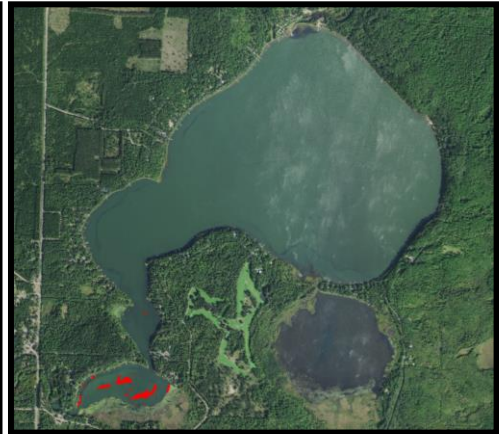
Lower Eau Claire Lake aerial photo with 2024 CLP beds.

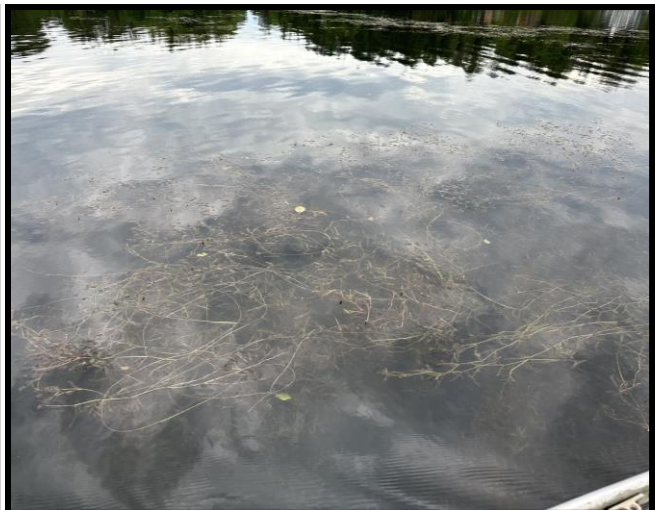
Curly-leaf pondweed in the outlet bay breaking free of the bottom – 6/15/24
