**Curly-leaf pondweed (*Potamogeton crispus*)  
Bed Mapping Survey  
Middle Eau Claire Lake – WBIC: 2742100  
Bayfield County, Wisconsin**

Endangered Resource Services, LLC  
Matthew S. Berg, Research Biologist  
St. Croix Falls, Wisconsin  
June 15, 2024

As these surveys found only small amounts of CLP that were generally minor components within expansive beds of beneficial habitat-forming native vegetation, it was decided to limit control of CLP to manual removal by volunteers. However, when a follow-up CLP bed mapping survey in 2015 found expanding numbers of small beds on both lakes, it was determined that suction harvesting using the "Barnes Aquatic Invasive Species Sucker" or BAISS would be employed to increase capacity. BAISS harvesting continued from 2015-2022 with occasional CLP bed mapping surveys used to guide harvesting and assess the efficacy of the program. Following the uptick in acreage we documented in 2021, we were again asked to conduct bed mapping surveys to assess the effectiveness of early-season BAISS removal and to look for new areas with CLP in 2022, 2023, and 2024. This report is the summary analysis of our June 15, 2024 survey.

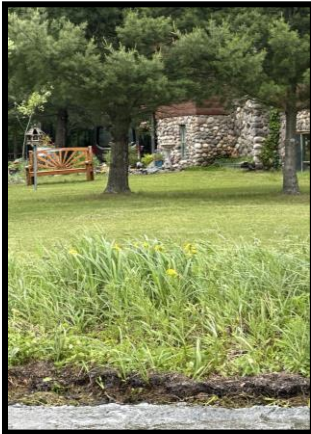
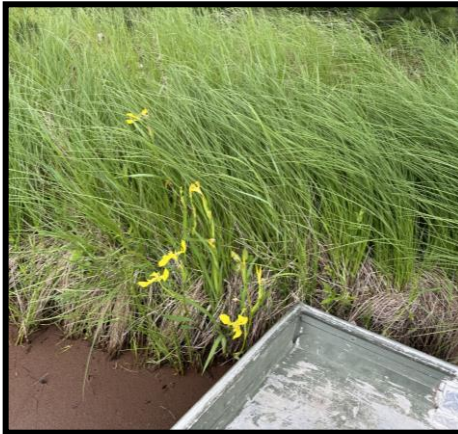
Yellow iris near the Bony Lake Inlet

Close-up of Yellow iris - 6/15/24

The presence of Yellow iris near and in the Bony Lake Inlet is troubling as there are currently no biological control agents for this species. Because iris can spread rapidly, we STRONGLY encourage residents to look for and eliminate plants on their property before a minor problem becomes a significant one. Iris plants and pods should be bagged to prevent seed dispersal and then disposed of well away from the lake or any other wetland. June is the best month to look for this species as the bright yellow fleur-de-lis are most common at this time of year (see photo on the front cover of this report).

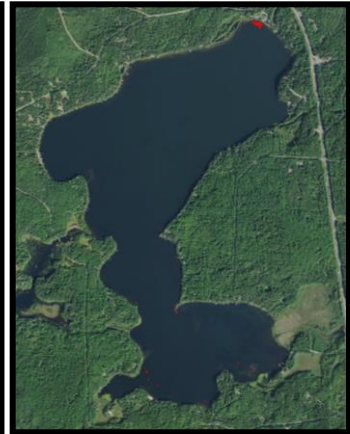
2024 Middle Eau Claire Lake CLP Beds (red)

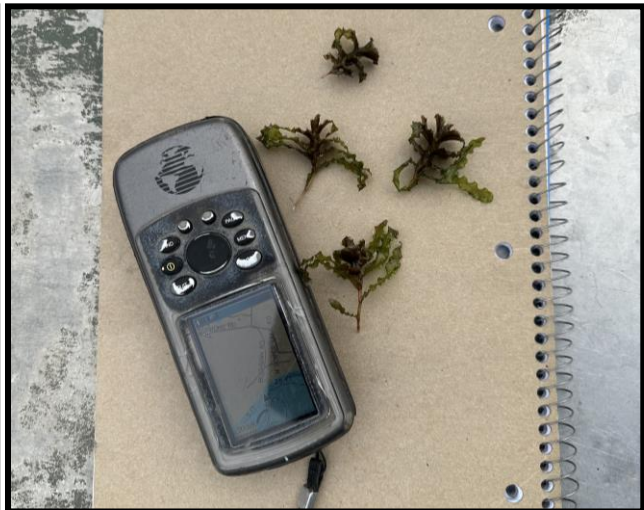
Curly-leaf pondweed with turions breaking free - 6/15/24

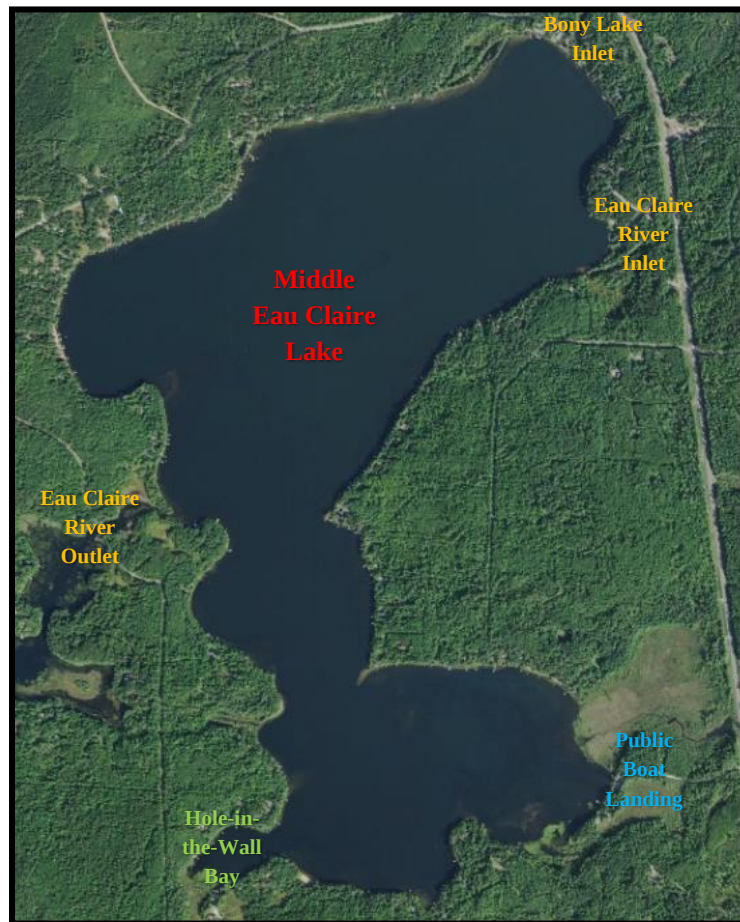
**Figure 1: Middle Eau Claire Lake Aerial Photo**

Middle Eau Claire Lake (WBIC 2742100) is an 880-acre stratified drainage lake located in southwestern Bayfield County, Wisconsin in the Town of Barnes (T44N R9W S7-9 and 16-21). It reaches a maximum depth of 66ft in the hole north/northwest of the Eau Claire River Inlet and has an average depth of approximately 17ft (Figure 1). The lake is mesotrophic bordering on oligotrophic in nature with summer Secchi readings over the last ten years averaging 16.4ft (WDNR 2024). This very good clarity produced a littoral zone that reached approximately 20ft in 2024. The bottom is predominately sand and gravel along the shoreline and around the many sunken islands, while muck dominates the deeper basins and bays (Hopke et al. 1964).
