**Eurasian water-milfoil (*Myriophyllum spicatum*)  
Late Summer Bed Mapping Survey  
Sand Bar Lake - WBIC: 24924900  
Bayfield County, Wisconsin**

**Project Initiated by:**

The Town of Barnes – Aquatic Invasive Species Committee and the Wisconsin Department of Natural Resources

Endangered Resource Services, LLC  
Matthew S. Berg, Research Biologist  
St. Croix Falls, Wisconsin  
September 3, 2023

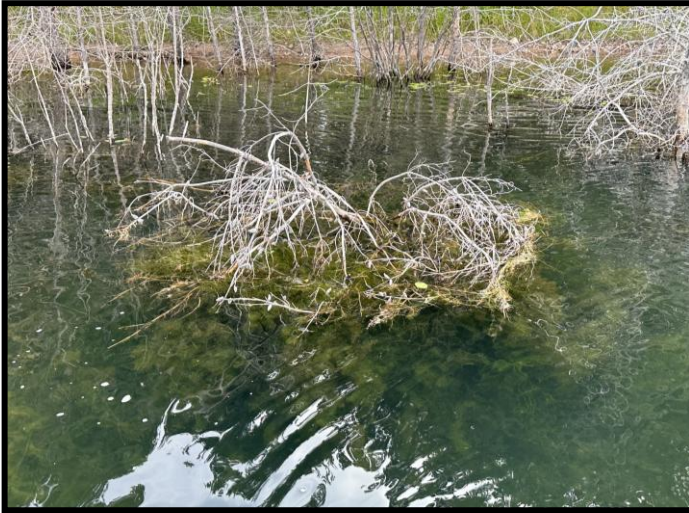
EWM among the dead jack pine along Sand Bar Lake's shoreline - 9/3/23

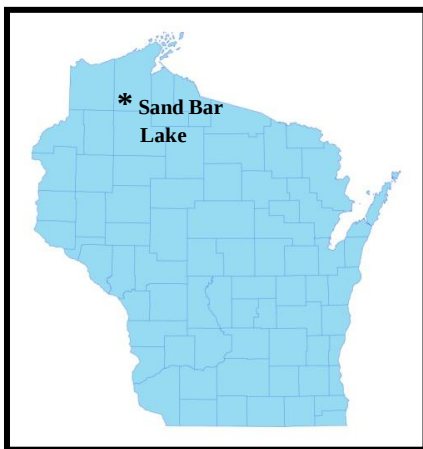
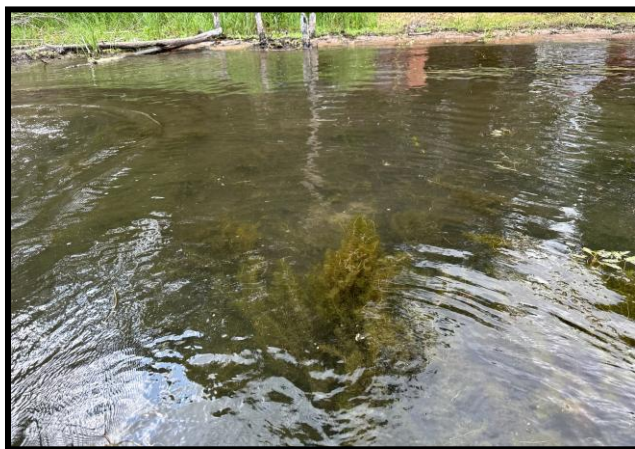
Typical canopied clusters on Sand Bar Lake's west side – 7/5/23

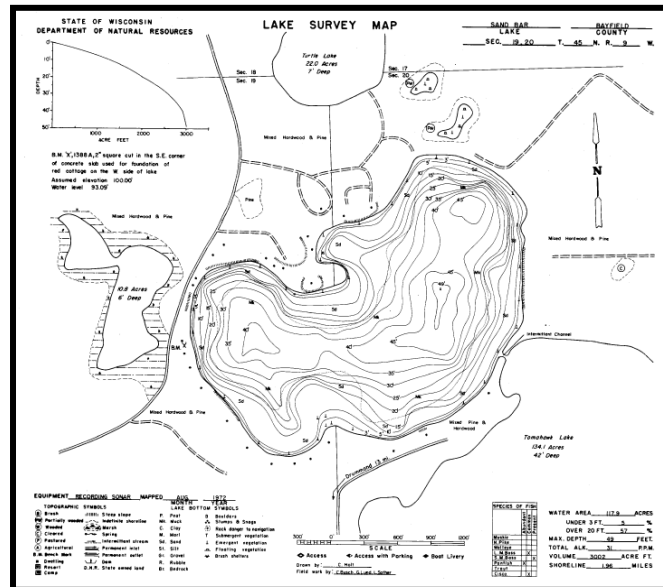
**Figure 1: Sand Bar Lake Bathymetric Map**

Sand Bar Lake (WBIC 2494900) is a 127-acre stratified seepage lake on the west-central edge of Bayfield County, Wisconsin in the Town of Barnes (T45N R9W S19/20). It reaches a maximum depth of 49ft on the east side and has an average depth of approximately 25ft. The lake is oligotrophic in nature with Secchi readings taken over the summer of 2023 averaging 18.8ft (WDNR 2023). This good water clarity produced a littoral zone that extended to at least 20ft. The bottom substrate is predominately sand along the shoreline, but this gradually transitions to sand with a thin top layer of muck at most depths over 6ft (Figure 1) (Holt et al. 1972).

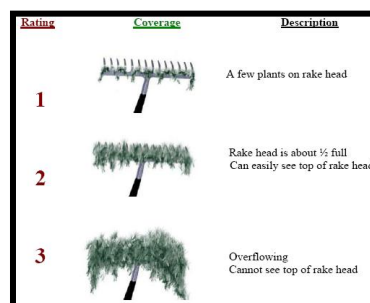
Figure 2: Rake Fullness Ratings (UWEX 2010)

During the survey, we searched the visible littoral zone of the lake. By definition, a “bed” was determined to be any area where we visually estimated that EWM made up >50% of the area’s plants, was generally continuous with clearly defined borders, and was canopied or close enough to being canopied that it would likely interfere with boat traffic. After we located a bed, we motored around the perimeter taking GPS coordinates at regular intervals. We also estimated the rake density range and mean rake fullness of the bed (Figure 2), the range and mean depth of the bed, whether it was canopied, and the impact it was likely to have on navigation (**none** – easily avoidable with a natural channel around or narrow enough to motor through/**minor** – one prop clear to get through or access open water/**moderate** – several prop clears needed to navigate through/**severe** – multiple prop clears and difficult to impossible to row through). These data were then mapped using ArcMap 9.3.1, and we used the WDNR’s Forestry Tools Extension to determine the acreage of each bed to the nearest hundredth of an acre. Because the goal of the survey was to identify all areas of the lake with significant EWM, we also mapped “high density areas” where EWM plants were continuous but didn’t meet all of the other “bed” criteria.

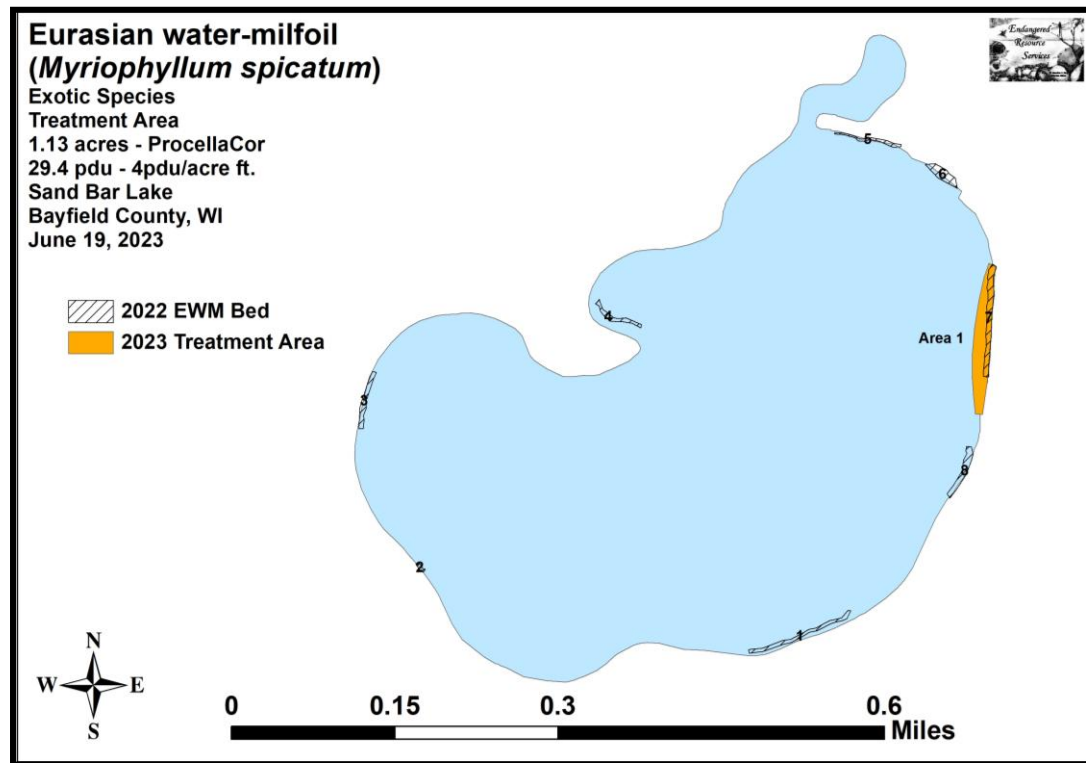
**Figure 3: Eurasian Water-milfoil Treatment Areas - June 19, 2023**

The single treatment area along the lake's eastern shoreline just north of the channel between the lakes totaled 1.13 acres (0.89% of the lake's total surface area) (Table 1). Treatment occurred on June 19<sup>th</sup> with Northern Aquatic Services (Dale Dressel - Dresser, WI) applying ProcellaCor at a target rate of 4pdu/acre-ft (29.4 total pdu) (Figure 3) (Appendix I). The reported water temperature at the time of treatment was 70°F, the ambient air temperature was 74°F, and winds were out of the south/southwest at 3mph.

The 2023 treatment provided effective control of EWM within Bed 7, and adjacent shallow areas also seem to experience residual control. Unfortunately, EWM's expansion elsewhere in the lake more than offset this control. Complicating future management, many of the remaining beds are essentially inaccessible within the "dead tree forest". Because of this, manual removal is likely not possible due to the danger of air hoses becoming entangled in the dead trees. Although it is unlikely that these beds will become a significant navigation impairment in 2024, the widespread establishment of EWM around the lakeshore likely means these areas will continue to expand. Whether this constitutes a need for expanded active management in 2024 needs to be discussed. Likewise, there should be a decision made on how much monitoring, if any, will be needed in 2024. Ultimately, the TOB, LEAPS, and the WDNR will have to decide on a future course of action.

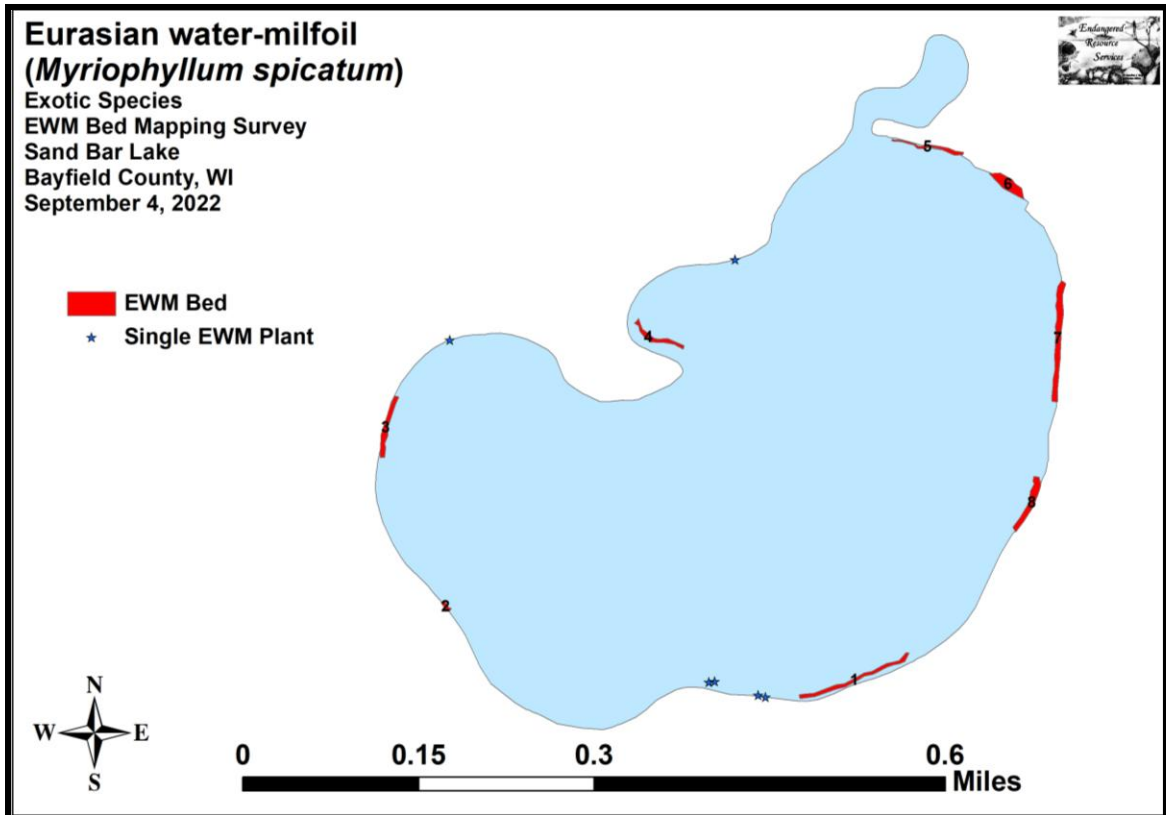
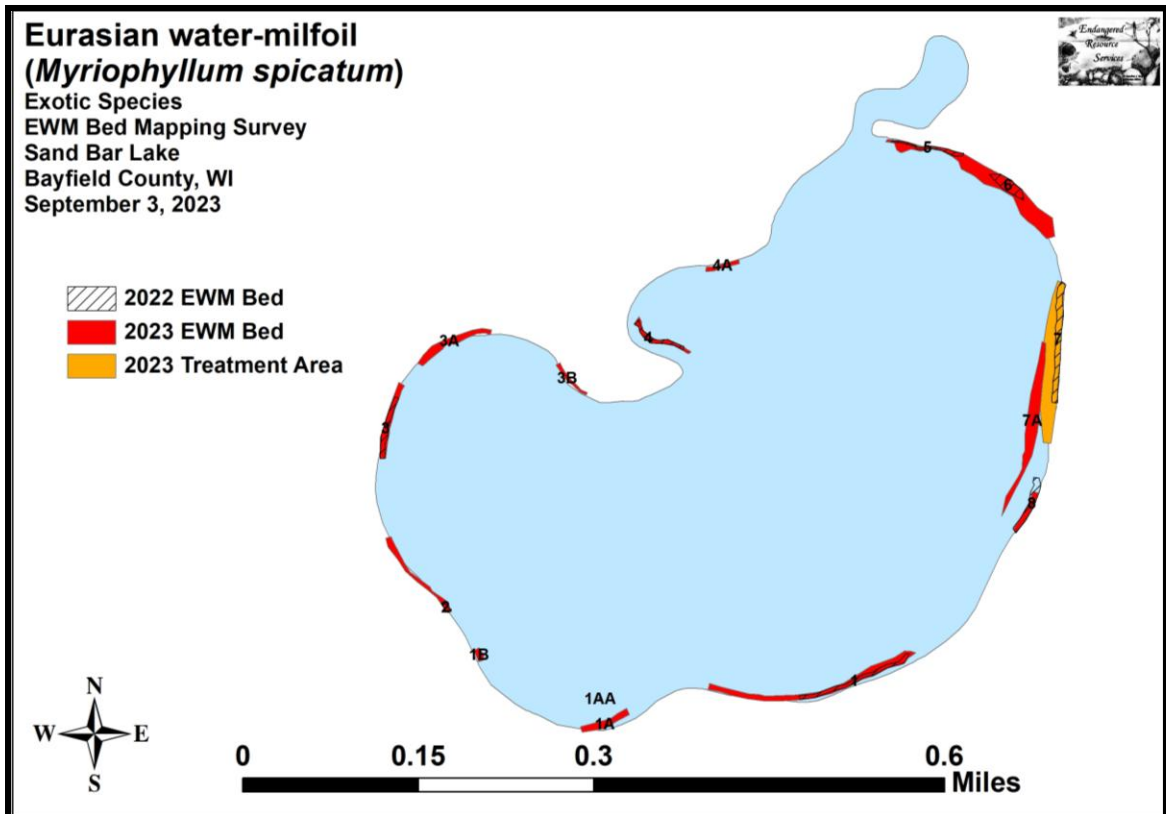
**Figure 6: 2022 and 2023 Late Summer Eurasian Water-milfoil Bed Maps**

On September 4, 2022, we searched 10.4km (6.5 miles) of transects throughout the lake's visible littoral zone (Figure 4). We had mostly sunny skies and relatively calm winds that allowed us to see down in the water approximately 7-8ft. Whereas we saw no evidence of Eurasian water-milfoil in Tomahawk Lake, we immediately noted floating fragments were common and found plants and clusters of plants were establishing among the dead Jack pines (*Pinus banksiana*) around much of the lake (Figure 5). In total, we mapped 13 areas covering 3.47 acres (2.73% of the lake's surface areas) (Figure 6). This represented a 186.77% increase over 2022 when we found eight beds covering 1.21 acres (0.95% surface area) (Table 1).

Beds 1 and 1A – Each of these beds was a nearly continuous ribbon of pioneer plants and merging clusters. In each case, Eurasian water-milfoil was almost exclusively confined to the immediate shoreline where it was growing among dead Jack pines that had been killed by rising lake levels after decades of low water. Because EWM in Bed 1 was completely imbedded in these “flooded forests”, it was not an impairment to navigation. However, Bed 1A might have posed a minor impairment for residents as most of it was beyond the trees and occurred in front of several docks.

Bed 1AA – This subcanopy microbed occurred in deepwater. It is probably a harbinger of things to come in 2024 as we noted pioneering plants expanding outward from most shallow shoreline beds.

Beds 1B, 2, and 3 – Each of these beds along the western shoreline had significant gaps in them as many residents were taking it into their own hands to rake out plants. In undeveloped shoreline areas, EWM tended to have higher densities.

Beds 3A, 3B, and 4 – Beds in the north bays were still largely restricted to shallow areas along the immediate shoreline, but we noted there were increasing numbers of small subcanopy pioneer plants in deeper water. Each of these areas was more a collection of merging patches than a solid bed so they likely weren’t causing more than minor impairment to residents.

Bed 4A - Similar to Bed 1, EWM in this area was largely restricted to growing among the ring of dead trees. Because of this, it is currently unlikely to be an impairment to navigation.

Beds 5 and 6 – The core areas we mapped in 2022 had become canopied mats. In between these dense areas, regular plants and microbeds were rapidly expanding creating a single large superbed.

Bed 7 – We saw no evidence of EWM in the treatment area formerly covered by Bed 7.

Bed 7A – Just outside the treatment area, we found low-density but regular plants establishing on the slope to deep water. It’s possible that they were recently established from surrounding areas or even from a seed bank. Regardless, this seems to be one of the first places on the lake that EWM takes hold as this area is often targeted by the BAISS boat.

Bed 8 – The bed near the channel to Tomahawk Lake was the worst area on Sand Bar in 2022, but it had only scattered plants in 2023. This suggests that the adjacent treatments in Tomahawk and/or Sand Bar may have provided residual control to this area. Although still not an impairment to navigation, wave action was causing the plants growing in open water to break apart, and we again saw a concentration of floating fragments throughout this area.
